The overall objective of this experiment is to demonstrate that this type of equipment can successfully be operated on E-85 ethanol blend fuel instead of gasoline. The objective of this report is to document the materials compatibility observations of a carburetor repair, at 15 month's exposure. The repair was occasioned by a fuel leak, caused by old age, not exposure.

The equipment was a 1973-vintage Volkswagen Type 1 standard "beetle" in more-or-less factory configuration. The vehicle is fitted with an intake manifold vacuum gage, and the trigger and power wires for a tachometer. It is an extremely high-time piece of equipment. Once the conversion efforts began to "gel", a Solex 30PICT-2 carburetor was selected for both the gasoline baseline and for E-85 documentation purposes. This carburetor required an adapter plate to fit the 34 mm manifold flange pattern, which in turn required the accelerator pump cover and linkage rod assembly off a Solex 30/31 carburetor in order to fit the adapter plate.

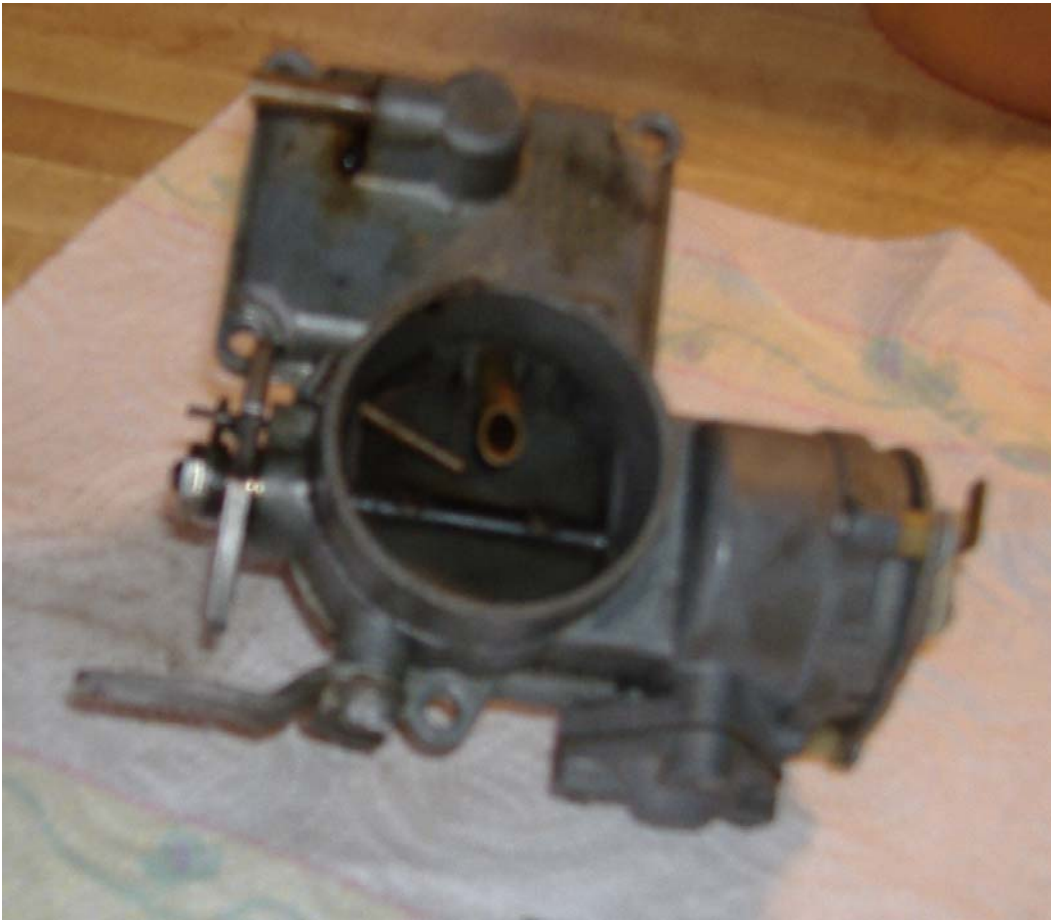
**Figure 1 – Top View of Carburetor Before Disassembly and Inspection: External Surfaces Are Cleaner Than Was Usual With Gasoline.**

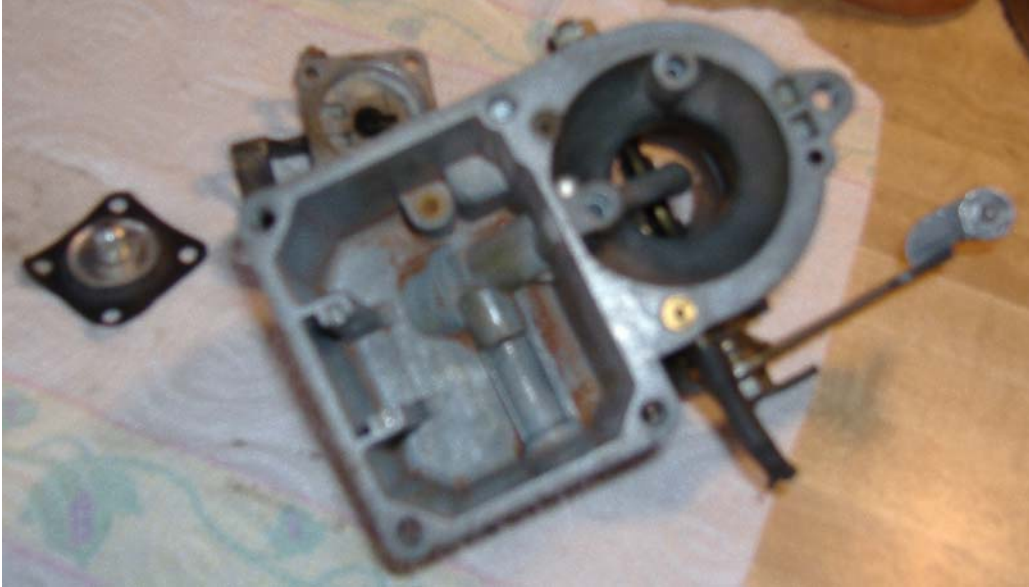
Data were collected by log entry and by photography. The carburetor was found to be startlingly clean: no “Chem-Dip” cleaning was required at all. In point of fact, the E-85 seems to do a better job as a cleaning agent, as the ancient varnish deposits were softened or completely removed. Those remaining were simply wiped away with a paper towel.

**Figure 2 – Bowl View: Softened Red Varnish Deposit on the Left Came Out to the Touch. Note Just How Clean the Aluminum Casting Generally Is, Inside the Bowl.**

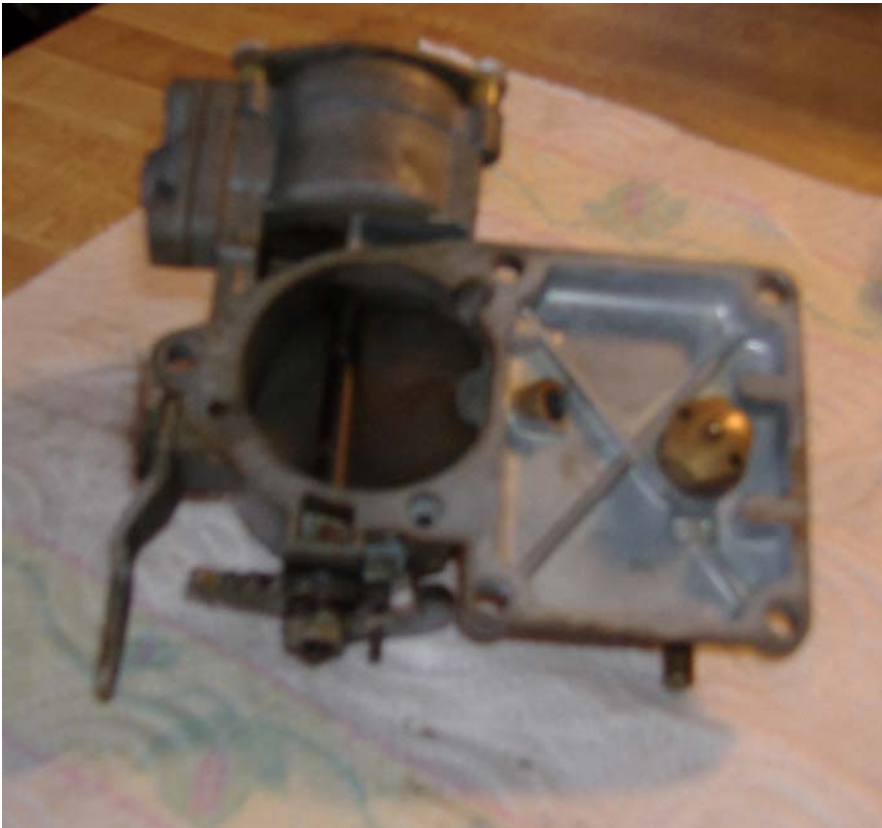
**Figure 3 – View Into Top Cover: Note Pristine Float Valve and Clean Casting.**

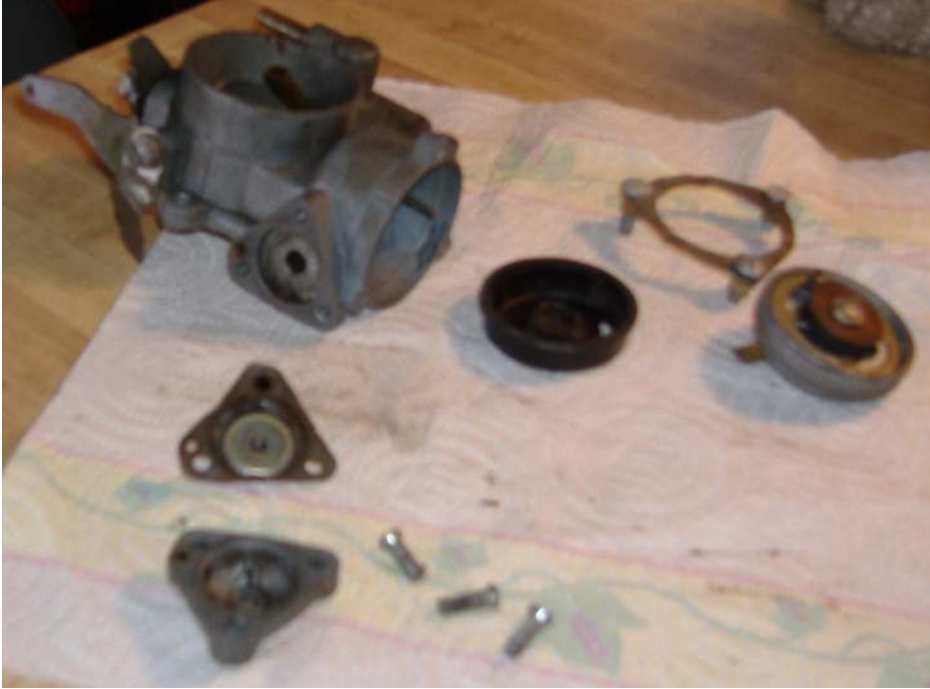
The choke vacuum diaphragm was found to be worn, and had shed rubber on the side away from the casting. There was no fuel wetting in this area. This part is very old, and may in fact be the original from 1969 (the vintage of the vehicle from which this carburetor came).

**Figure 4 – Top Cover Parts Were Not Immersed; the Vacuum Diaphragm Was Worn Due to Age, not Exposure.**

The manifold gasket, the float valve, the carburetor gasket, the float valve seal, the bowl plug seal, and the two diaphragms were replaced with new items from a carburetor rebuild kit covering this model. The kit was quite old, but its parts were in very good shape.

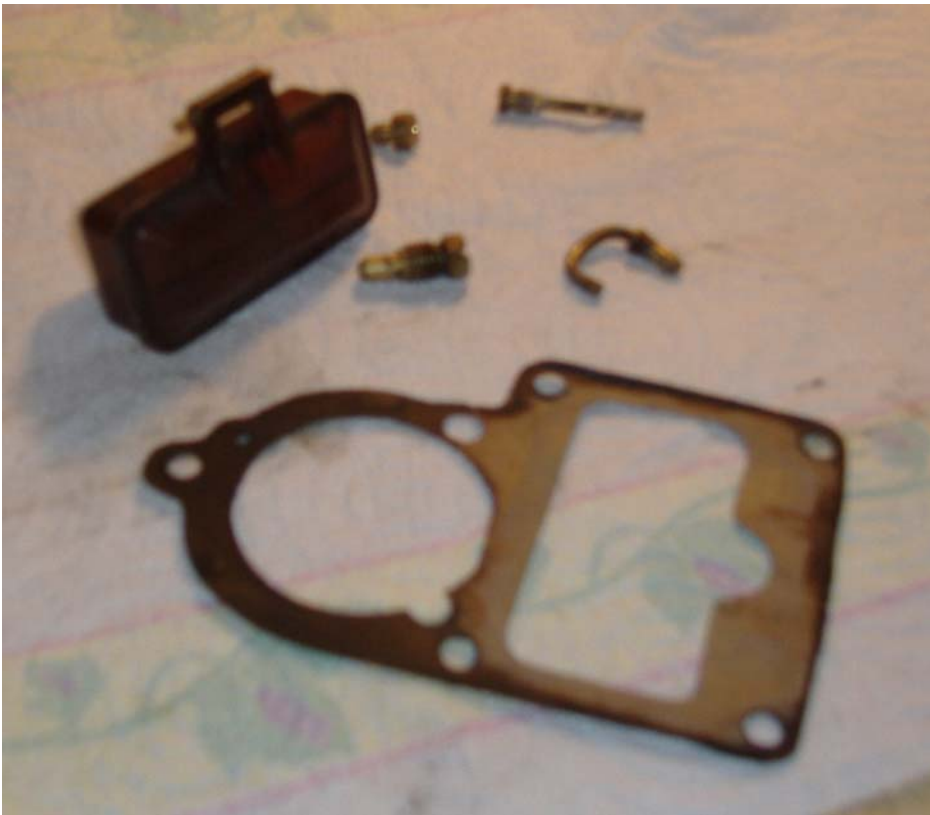
There were no deposits, pitting, or corrosion found on the castings or any of the brass jets, emulsion tubes, or other small parts. Left to dry out in the air, a soft white film appears on the brass parts, but is easily wiped away. There were no cracks or any other changes visible in the casting: it looked “new”, for the first time in decades.

The paper gasket (already greased and re-used so many times before) was found cracked through one screw hole, although otherwise still in fair shape. There were no deposits on it, and it was not embrittled any more than any other aged gasket this author has seen, and he has seen many.

**Figure 5 – Float and Jet Parts Pristine, Gasket Cracked at Screw Hole (Nearest Idle Jet).**

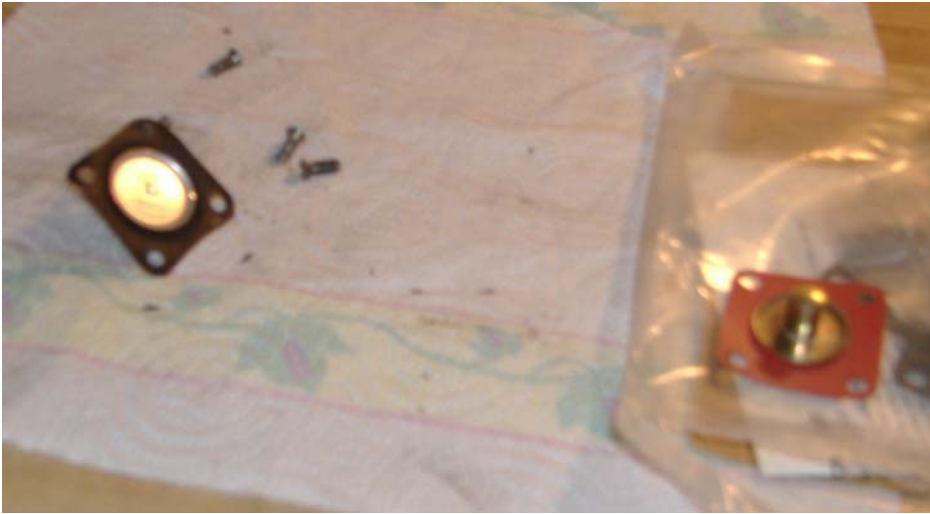
The accelerator pump diaphragm, a neoprene item, was in good shape, but the chromed steel parts that “clinch” it together had lost their grip. This opened up a leak path around the center shaft connecting the two metal disks. No corrosion or pitting was found, so this is presumed to be simple mechanical wear and tear on a part of considerable age.

**Figure 6 – Old Accelerator Pump Diaphragm is the Black Neoprene Part on the Left, Still Quite Pliable. The Metal Clinch Disks Were Loose, Causing the Leak. The New Red Neoprene Part is on the Right.**

Upon reassembly, the mismatched accelerator pump cover plate still leaked, this time out the top edge. This is due to the screws bottoming before the diaphragm can be clinched tight enough to seal. It was remedied by fashioning a thick card stock gasket to fit between the diaphragm and the cover plate. This shimmed-out the cover so that the screws did not bottom-out too soon.

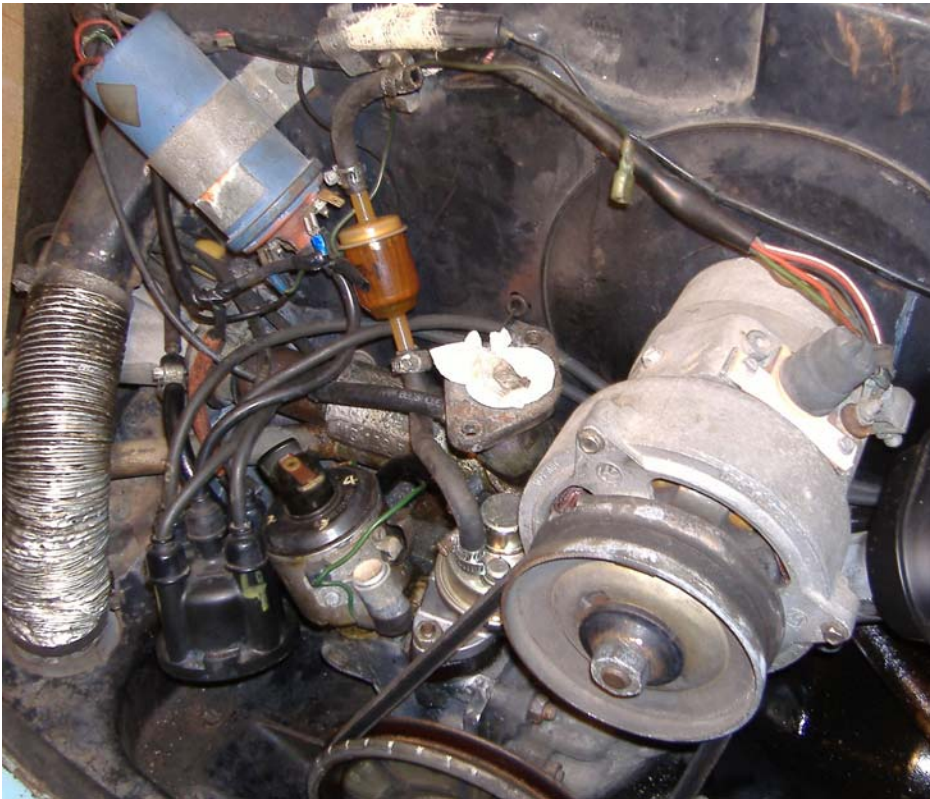
There was no damage of any kind seen on the plastic float valve, or the plastic fuel filter.

No debris of any kind was found in the carburetor bowl or the fuel filter (which was left in place).

**Figure 7 – View of the Engine with Carburetor Removed. Note the Pristine Fuel Filter, and the Excellent Condition of Black Neoprene Fuel Lines.**
